## **SCHEDULE OF DILAPIDATION**

**HMS GANGES, BUILDING 15  
SWIMMING POOL  
(INCLUDING MAIN WORKSHOP AREA)**

**Haylink Ltd  
P O Box 206  
Loughton  
Essex, IG10 1PL**

AJR/awm/src/ss/S4346  
2nd December 2010

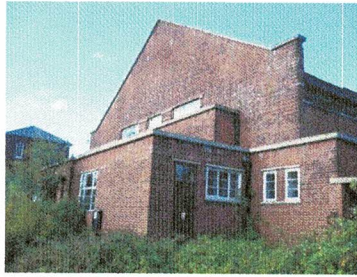
*Front/South*

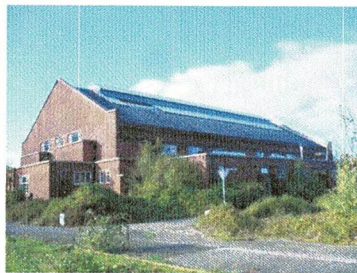
*East side*

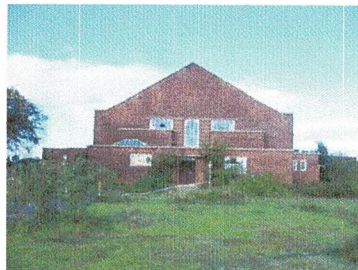
*North gable*

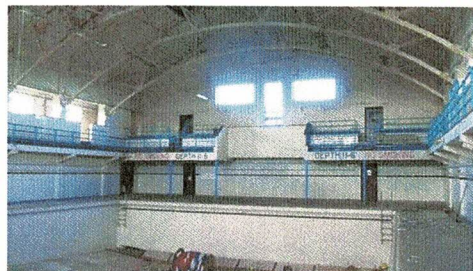
*Interior*
